PORT AUTHORITY OF NSW HERITAGE INVENTORY

State Heritage Inventory

SHI Number: 5063342		Study Number: N/A	
Item Name: Two Mooring Anchors			
Location: 4 Towns Place, Millers Point (Moores Wharf)			
Address: 4 Towns Place, Millers Point		DUAP Region: Sydney South	
Suburb / Nearest Town: Millers Point, 2000		Historic Region: Sydney	
Local Govt Area: Sydney		Parish: St Philip	
State: NSW		County: Cumberland	
Other/Former Names:			
Area/Group/Complex:			Group ID:
Aboriginal Area: Gadigal clan / Coodyee (Millers Point)			
Curtilage/Boundary:

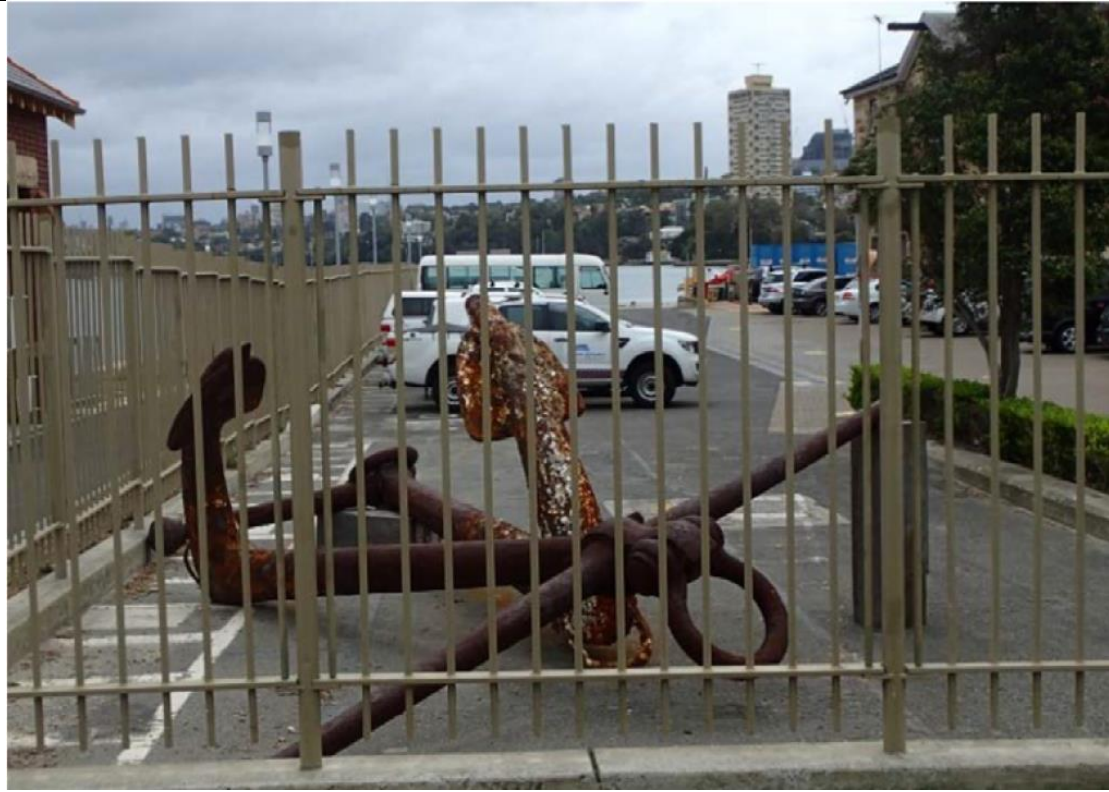
Image: 1

Caption: Admiralty Pattern mooring anchors at Moores Wharf, Walsh Bay

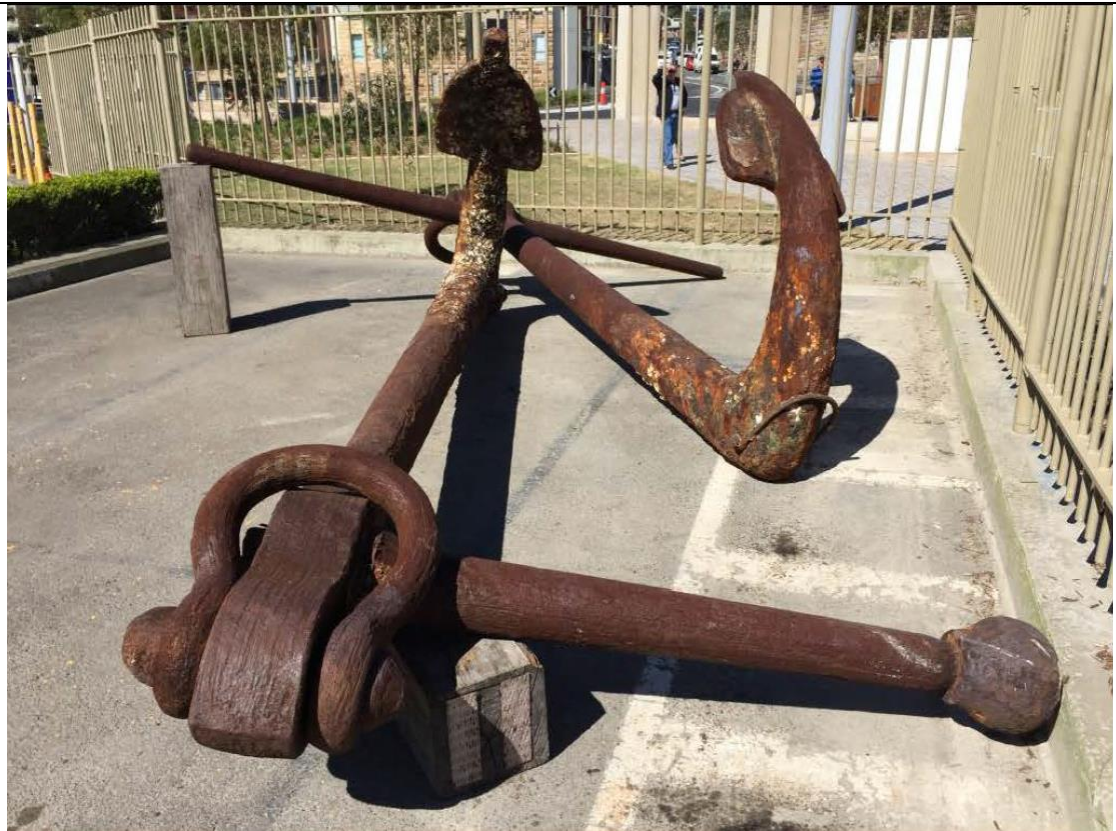
Image: 2

Caption: Admiralty Pattern mooring anchors at Moores Wharf, Walsh Bay

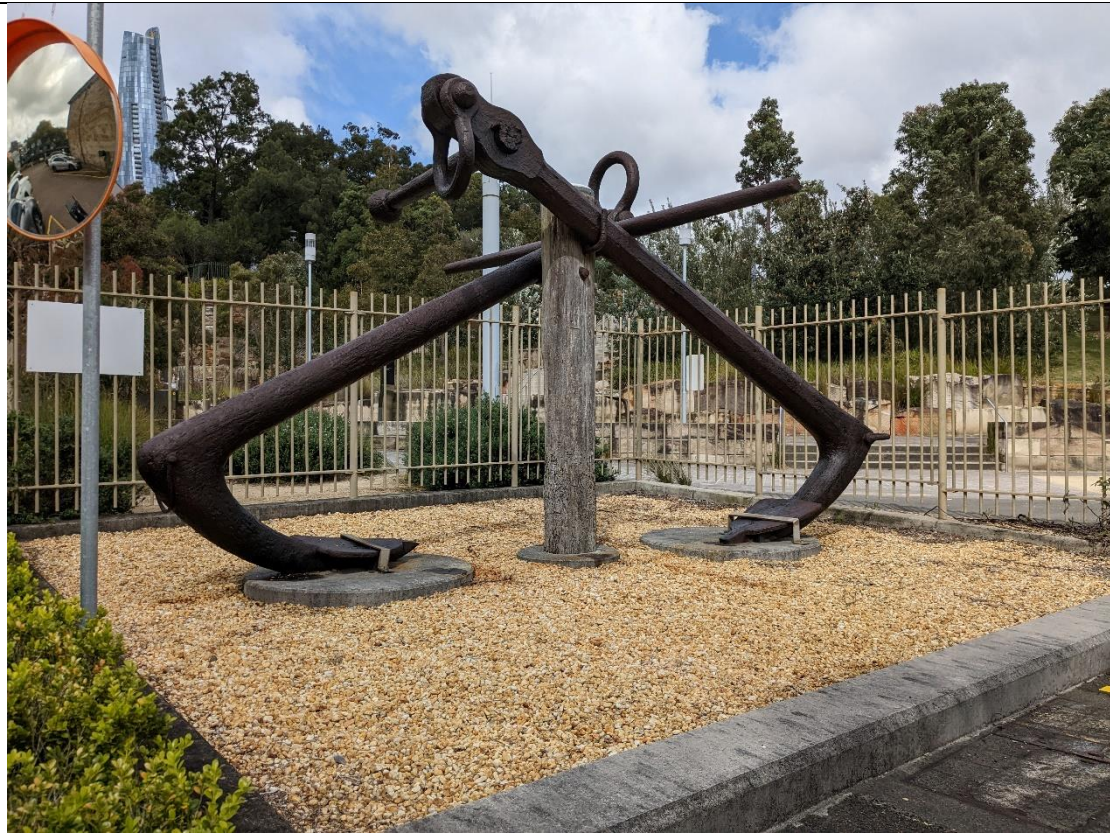
Image: 3

Caption: Admiralty Pattern mooring anchors at Moores Wharf
