USING PILOT LADDERS

This information sheet provides supporting information on the use of pilot ladders to complement that included in Marine Notice 2015/19.

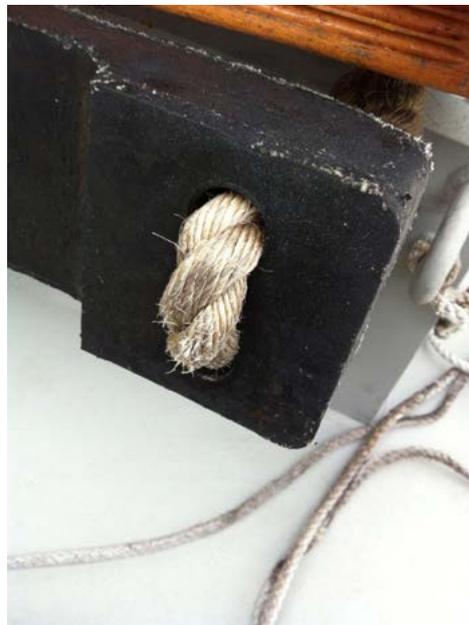
Figure 1

- Construction of the ladder is such that it does not ensure that the steps are prevented from moving (often due to chocks or step fixtures not being fitted above and below steps – refer Fig. 1 and 3)

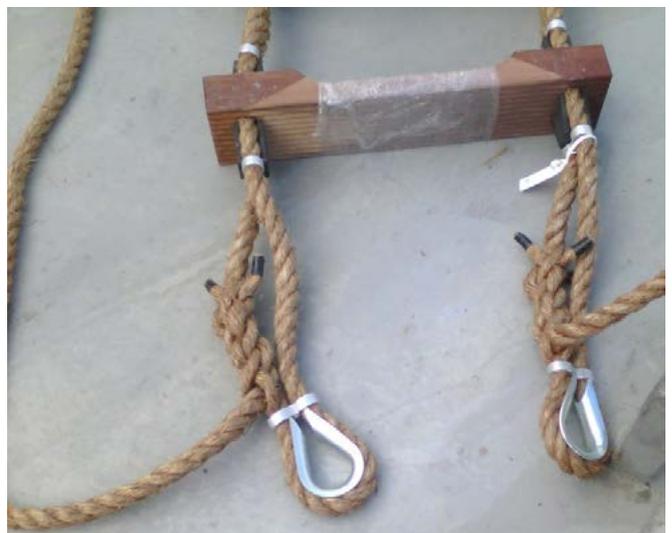
Figure 2

- Splices in side ropes (which are not permitted) (refer Fig. 2)
- Extension service ropes, if provided in accordance with ISO.799 (2004), must **not** be spliced into the side ropes but should be properly attached to the thimbles or directly to the ship (refer Fig. 2)

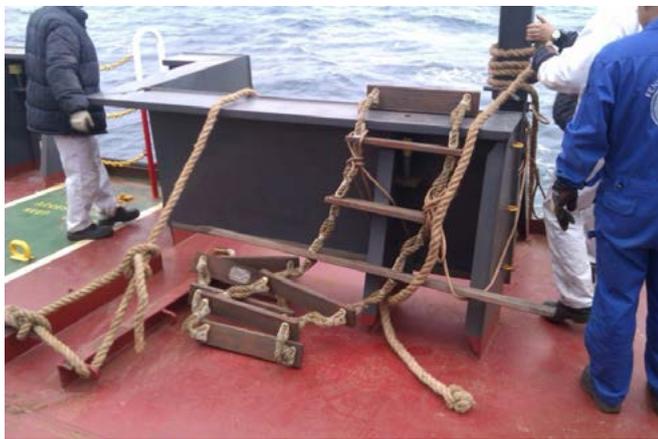
Figure 4

- Temporary and/or unsafe access or securing arrangements for the top end of ladder, such as cluttered attachment of man ropes at the head of the ladder (refer Figs. 4 & 5).

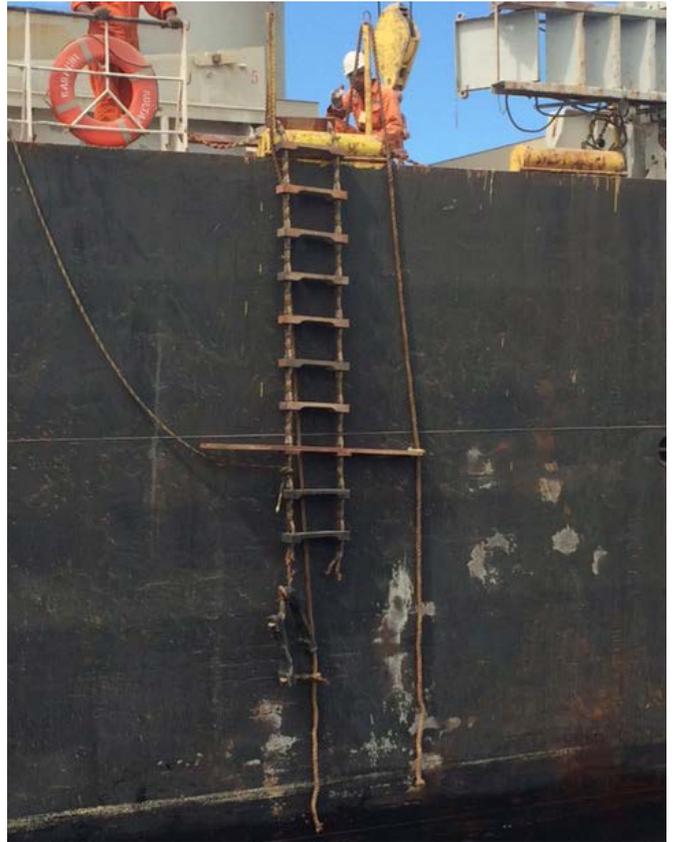
Figure 6

- The arrangement of pilot ladder and manropes are not rigged to pass through the trapdoor in the accommodation ladder platform as required by SOLAS reg. V/23.3.3.2.1.
- Retrieval lines (where considered necessary) not rigged in accordance with IMO Resolution A.1045(27).
- Man ropes, if required by pilots, not available or of incorrect diameter.
- Steps broken, not level or unevenly spaced (refer Fig. 6).
