PORT AUTHORITY OF NSW HERITAGE INVENTORY

SHI Number: 4560021		Study Number: N/A	
Item Name: Port Botany Old Government Wharf Remains			
Location: Port Botany, Banksmeadow			
Address: Port Botany		DUAP Region: Sydney South	
Suburb / Nearest Town: Banksmeadow 2019		Historic Region: Sydney	
Local Govt Area: Waterway		Parish: Botany	
State: NSW		County: Cumberland	
Other/Former Names: Long Pier; Government Pier			
Area/Group/Complex:		Group ID:	
Aboriginal Area:			
Curtilage/Boundary:

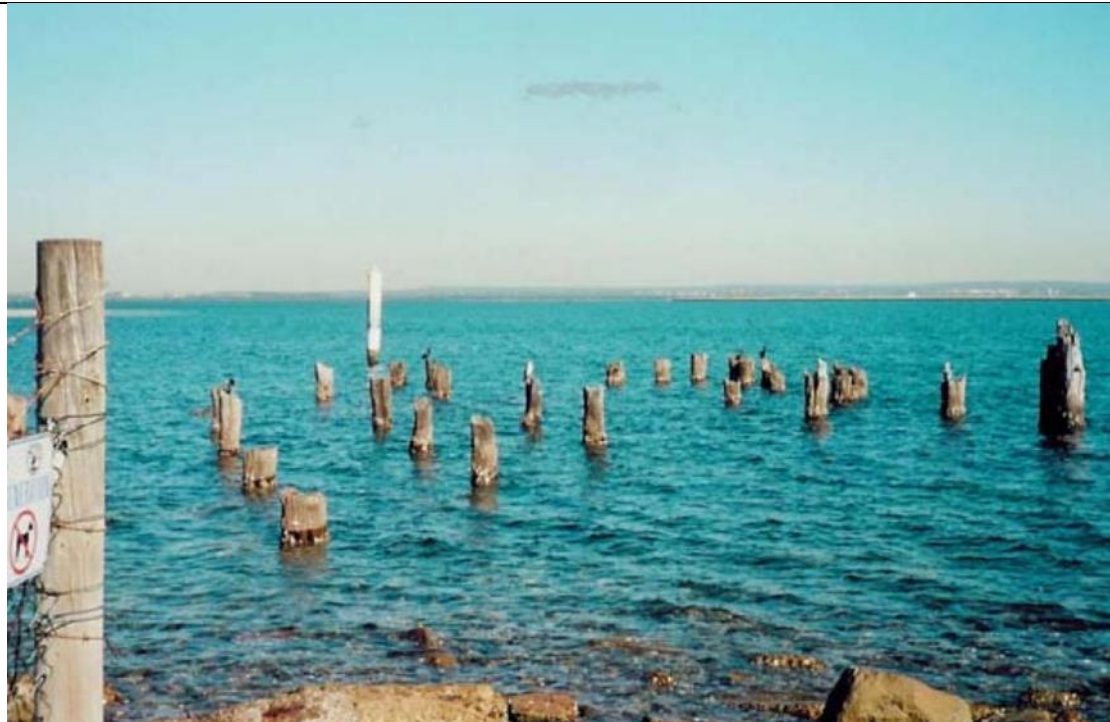
Image: 2

Caption: Port Botany Old Government Wharf Remains

Recommended Management: Retain in situ and conserve			
Management: Statutory Instrument			
Further Comments:			
Criteria a) The government wharf was a significant structure in the early history of the Port of Botany. It is associated with coal loading operations in relation to the nearby (but now demolished) Bunnerong Station. However little of the pier structure remains.			
Criteria b)			
Criteria c)			
Criteria d)			
Criteria e)			
Criteria f)			
Criteria g)			
Integrity / Intactness: The wharf was in a state of disrepair for many years leading to orders for its removal. Unsympathetic works were undertaken to prolong its commercial operation such as the dumping of mass bulk rock and building debris fill to support truck traffic. The wharf was partially burnt down and destroyed. The minimal physical fabric remaining consists of demolition debris at the landward end of the wharf and several posts located in the water itself.

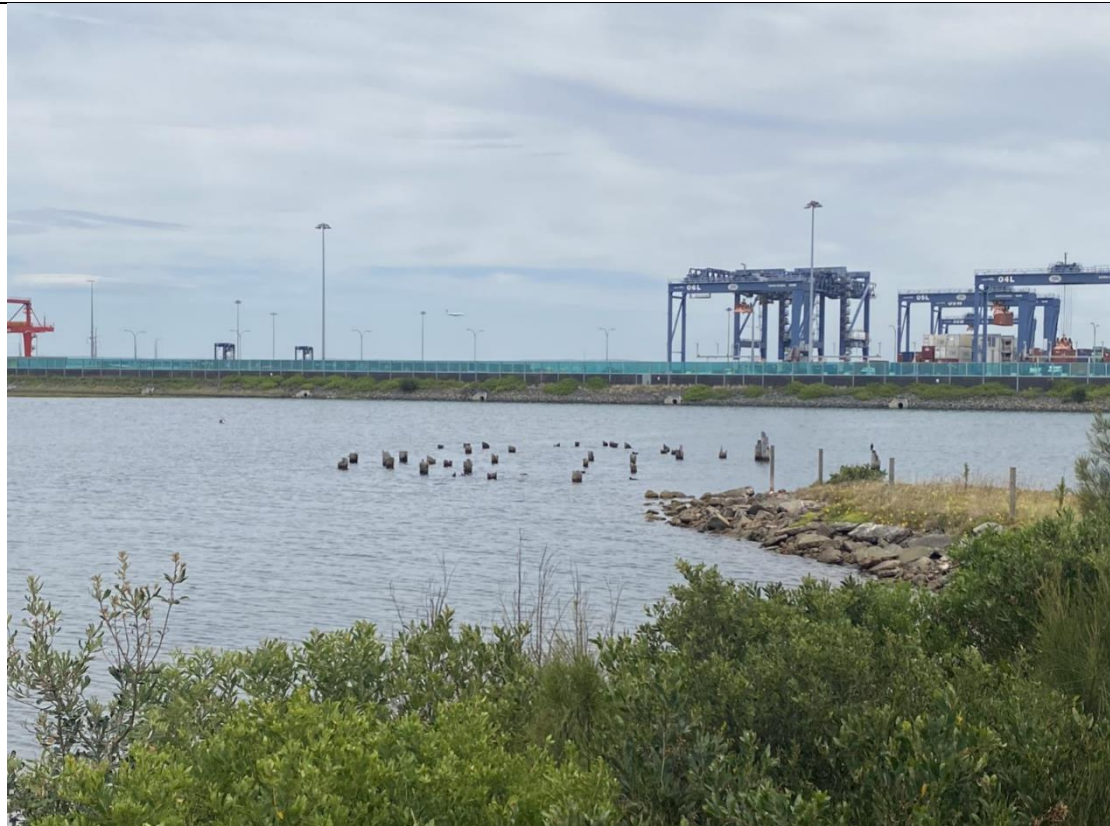
Image: 3

Caption: Port Botany Old Government Wharf Remains

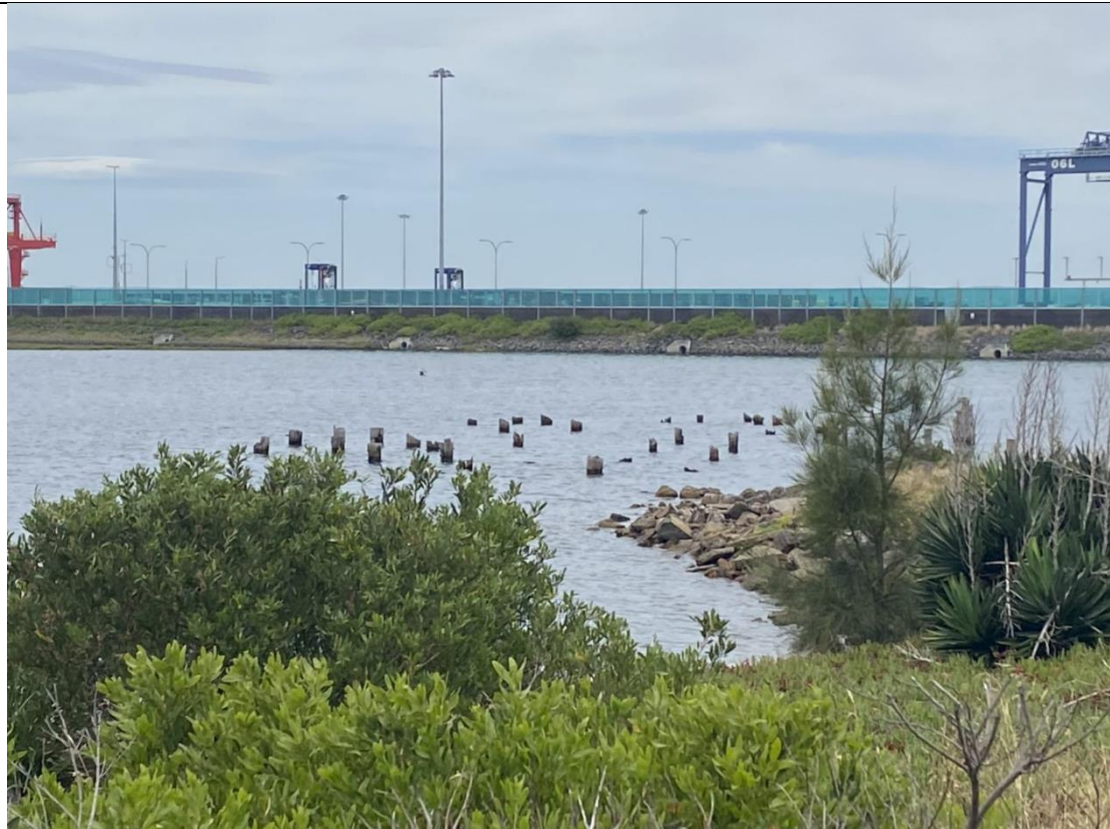
Image: 4

Caption: Port Botany Old Government Wharf Remains - Closeup
