Port Botany Foreshore Beach Groynes

Seagrass Survey After Construction

59916193

Prepared for
Ward Civil

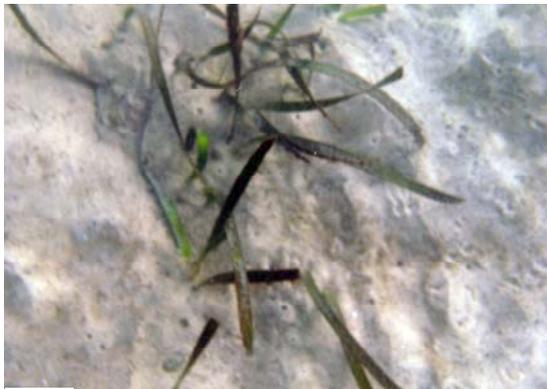
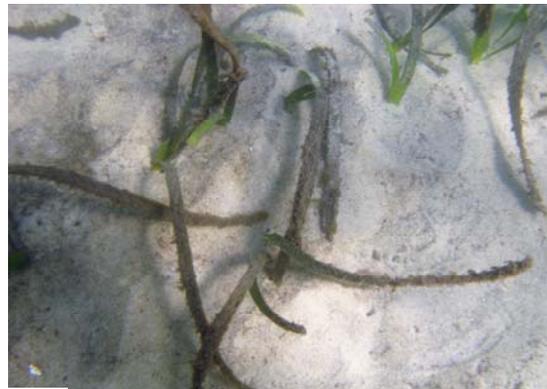
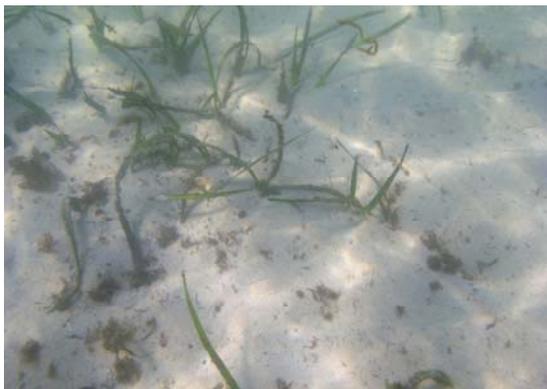
P. australis Patch 3 near the middle groyne, was present in December 2016 but it has steadily reduced in size from 31.3 m² (June) to 24.5 m² (September) to 13.9 m² (December) (**Table 3-1**). The condition of *P. australis* was similar (i.e. poor) in June, September and December 2016 with a thick cover of epiphytes (**Plate 1**).

Plate 1: *P. australis* at Patch 3 in June (a), September (b) and December 2016 (c) showing a thick cover of epiphytes

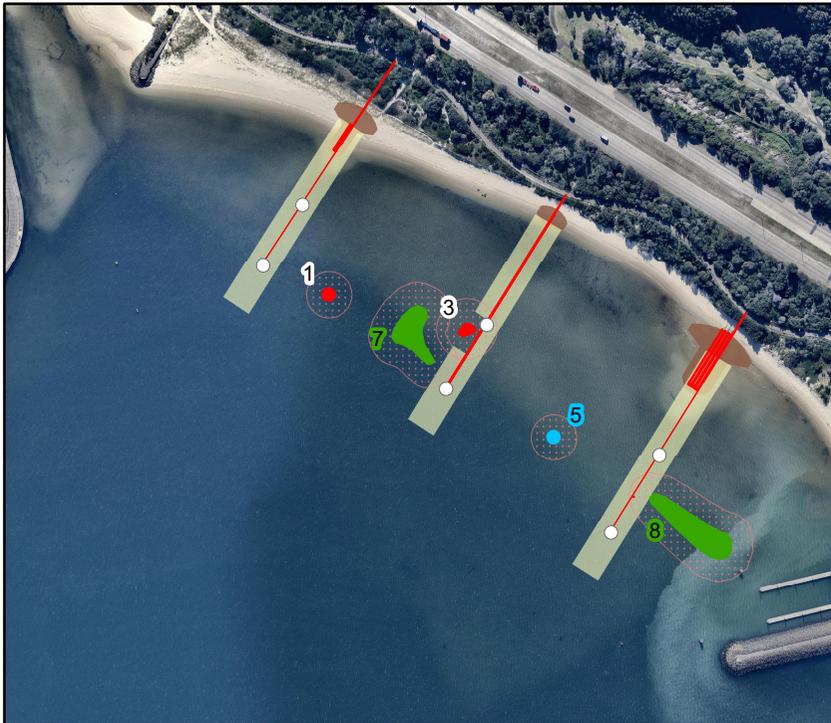
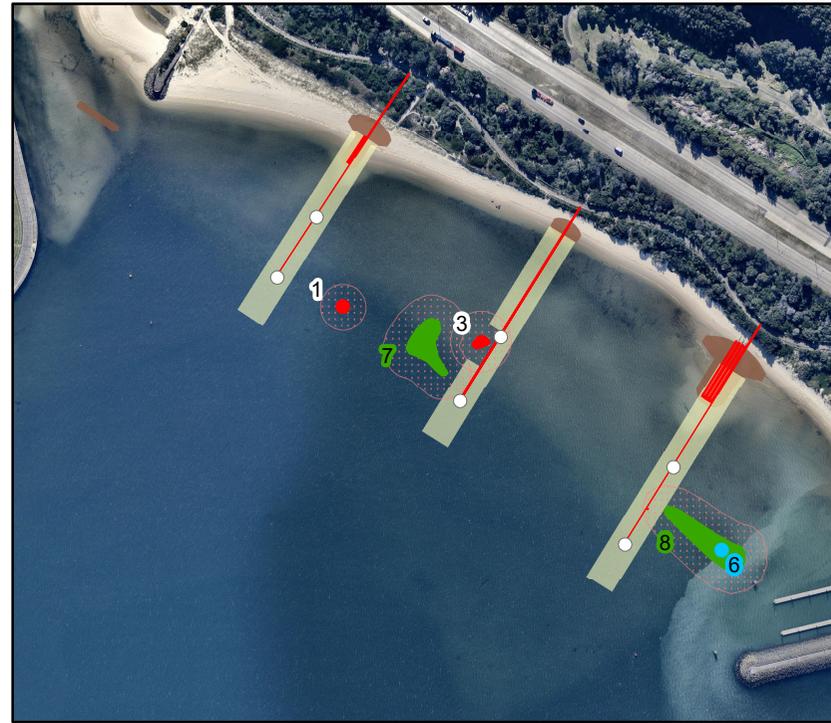
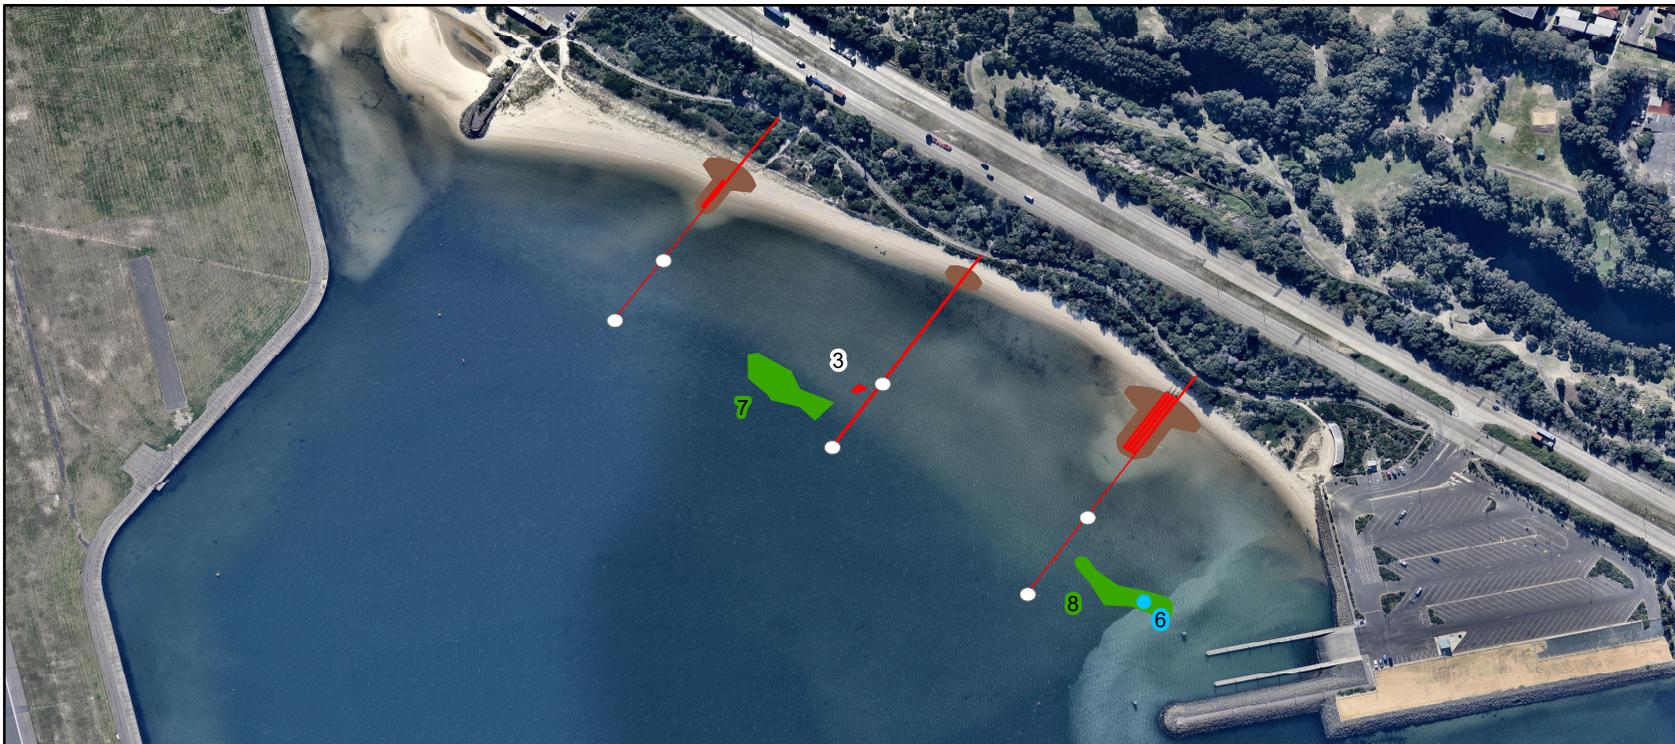
FIGURE 3-1

P. australis Patch 1, observed in the previous surveys was not present in December 2016 indicating the small (0.7 m²) patch had died since the previous (September) survey (**Figure 3-1**).

Comparison of beach seagrass:
 Top Left: June 2016
 Top Right: September 2016
 Bottom: December 2016

The patch of *Z. capricorni* (Patch 5) observed in June 2016 was unable to be located in September or December 2016. However, a patch (Patch 6) that was found in September 2016 close to the ramp, and away from the area of construction was again observed during the December 2016 survey with an area of 4 m² (Figure 3-1).

A check in the field of the locations of the edges of patches of *Halophila* spp. at Foreshore Beach indicated the extent of *Halophila* spp. (which co-existed with some *Z. capricorni*) at Foreshore Beach in December 2016 appears to be similar to June and September 2016 (Figure 3-1).

the construction area. At that time, the sand bund around the perimeter of the construction area failed and sections of silt curtains, put in place to protect seagrass beds near to the groyne construction areas, were compromised. The results of the survey, however, indicated that the severe weather conditions had little, if any, effect on seagrass at Foreshore Beach (refer to September Report for more detail, Cardno 2016b). Following this event, there was a small change made to the no anchoring zones (refer to **Figure 3-1**).

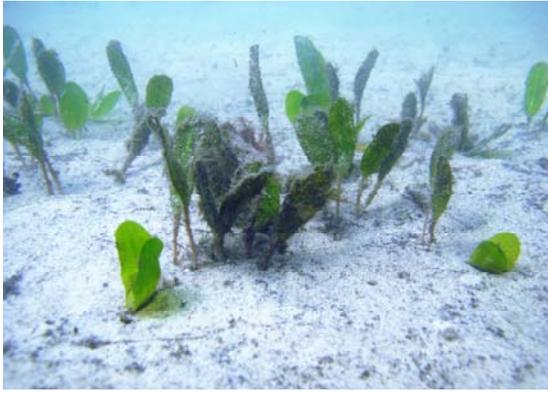
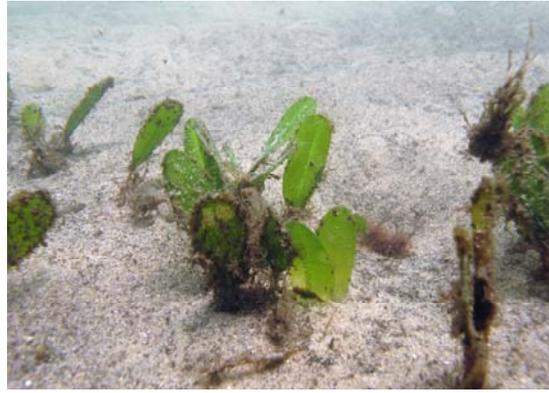
Compared to initial densities in June 2016, the mean density of *Halophila* spp. at Foreshore Beach increased up to five times in September 2016 and further increases were observed in December 2016. There proportional increases in density between September and December 2016 at Foreshore Beach were similar to what was observed at Yarra Bay (Table 3-3). Leaf length at all sites was similar but the cover of epiphytes on *Halophila* spp. at Foreshore Beach in December 2016 (Plate 2) appeared to be similar to that in June 2016 and slightly higher compared to Yarra Bay. Epiphyte cover at Foreshore Beach was generally greater than for Yarra Bay.

Plate 2: Epiphytes on *Halophila* sp. at Foreshore Beach in September 2016 (a) and December 2016 (b)
