Port Botany Foreshore Beach Groynes

Seagrass Survey During Construction

59916193

Prepared for
Ward Civil

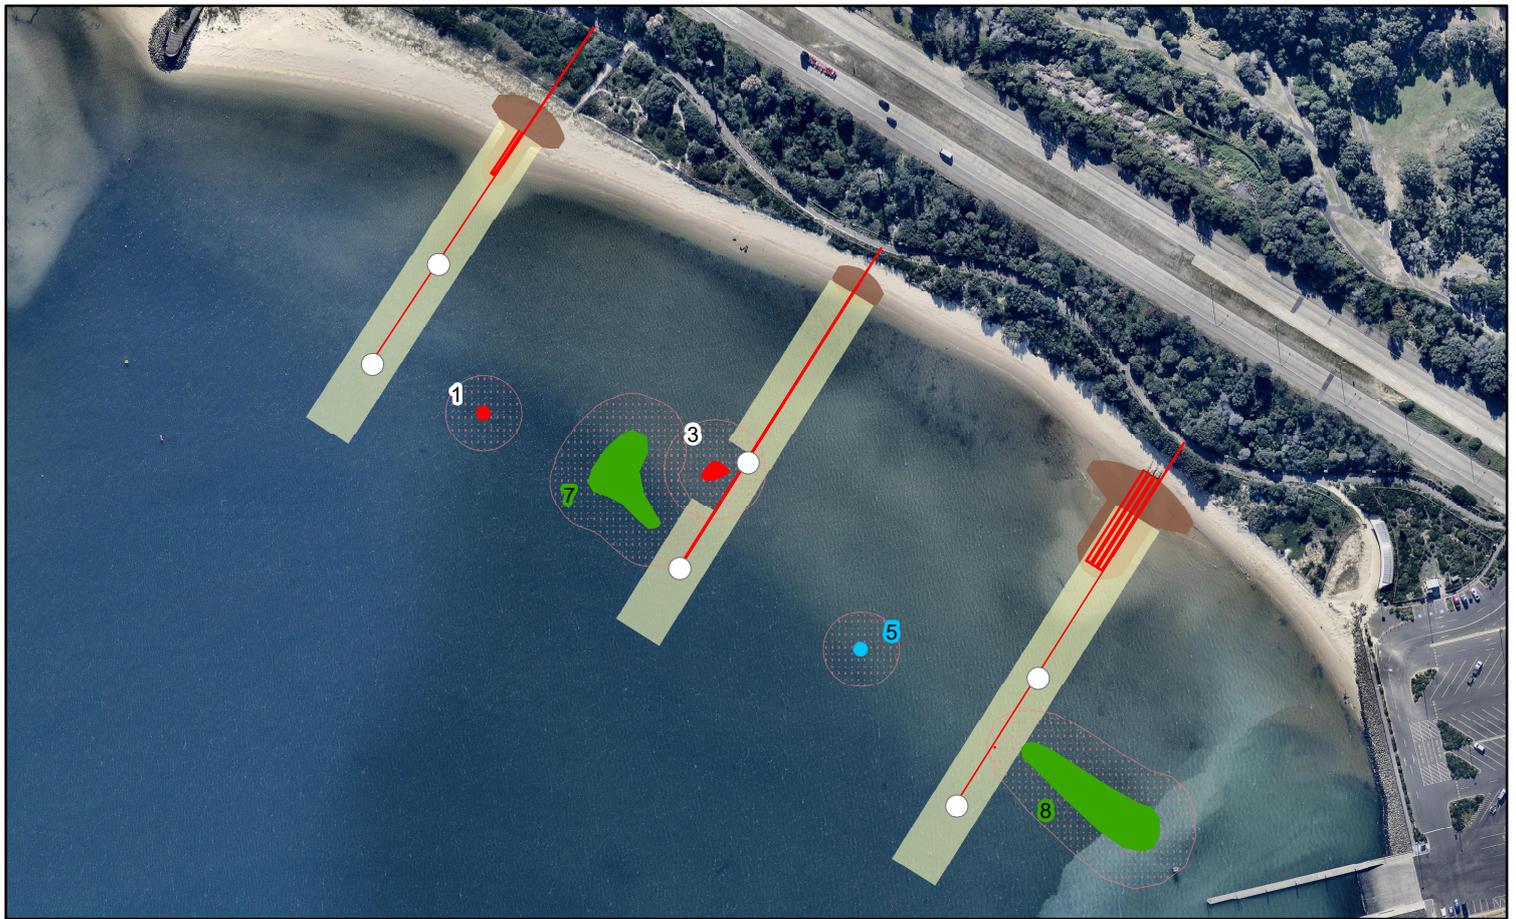
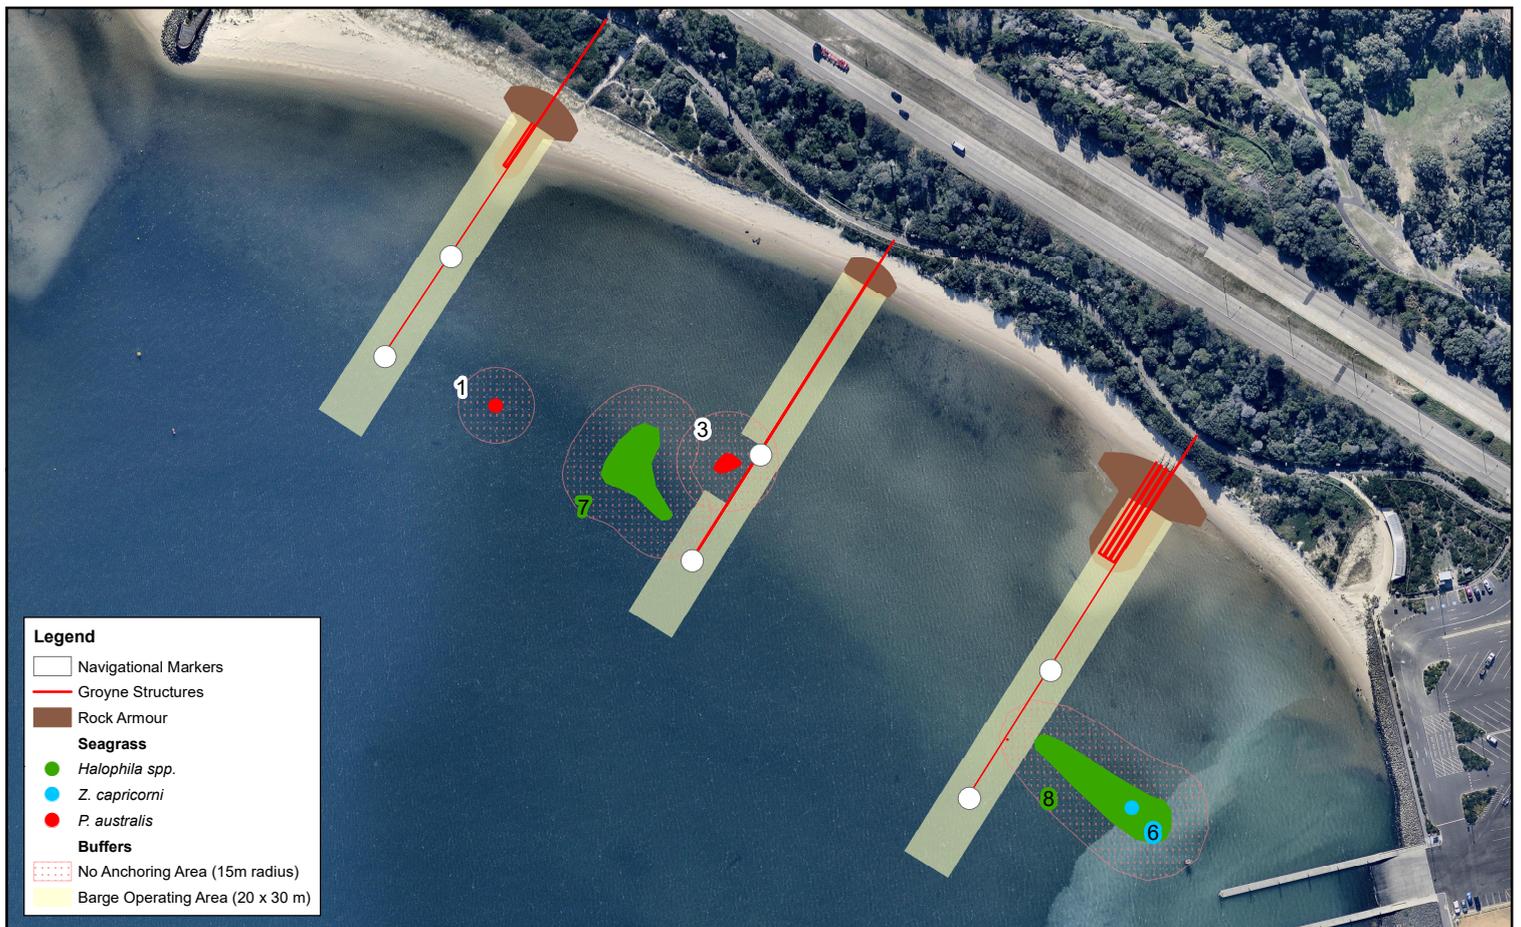
PORT BOTANY FORESHORE BEACH
 FIGURE 2-1

Comparison of Foreshore Beach Seagrass:
 Top: June 2016
 Bottom: September 2016

P. australis was observed at the two sites where it had been previously mapped in June 2016 (Patches 1 and 3) (**Figure 2-1**).

The two patches identified at Foreshore Beach in the current survey were confirmed to be further than 10 m of the proposed groyne structures (**Figure 2-1**). The western most of the three groynes is the closest (approximately 50 m) proposed structure to *P. australis* Patch 1. The middle groyne is closest (approximately 5 m) to *P. australis* Patch 3. The areas and cover of seagrass within both patches have changed very little since June 2016, although it is noted that the area of Patch 3 had declined by 6.8 m² since June 2016 (**Table 3-1**). The condition of *P. australis* was similar (i.e. poor) in June and September 2016 with a thick cover of epiphytes (**Plate 1**).

The patch of *Z. capricorni* (Patch 5) observed in previous surveys was unable to be located in September 2016. However, a new patch (Patch 6) was found in September 2016 close to the ramp, and away from the area of construction (**Figure 2-1**).

A check in the field of the locations of the edges of Patches 7 and 8 of *Halophila* spp. at Foreshore Beach indicated the extent of *Halophila* spp. (which co-existed with some *Z. capricorni*) at Foreshore Beach in September 2016 appears to be unchanged from June 2016 (**Figure 2-1**).

The 'Working Zones' of construction vessels are indicated in yellow in **Figure 2-1**. The Working Zone for the middle groyne has been modified so that it does not encompass *P. australis* Patch 3. Barges would be required to work only on the eastern side of the groyne during construction activities in the vicinity of *P. australis* Patch 3.

Two 'No Go Zones' have been identified to minimise the potential for damage to remnant patches (Patches 1 and 3) of the seagrass *P. australis*, which form part of a threatened population in Botany Bay (**Section 1**). These areas, indicated in solid red in **Figure 2-1**, are between the western and middle groynes. The construction Working Zone for the middle groyne has been modified specifically to avoid one of these two patches of seagrass which is located ~ 5 m from the groyne (see **Section 3.2.1**).

'No Anchoring Zones' have been marked in shaded pink in **Figure 2-1**. These provide an approximate 15 m buffer area around all seagrass patches at Foreshore Beach and are recommended as a measure to avoid anchor damage, including anchor chain scour and anchor-drag. These zones also apply to the positioning of jackup barge legs.

The proposed cardinal and special markers locations in the middle and seaward end points of the groynes are suitable and not located on seagrass (**Figure 2-1**).

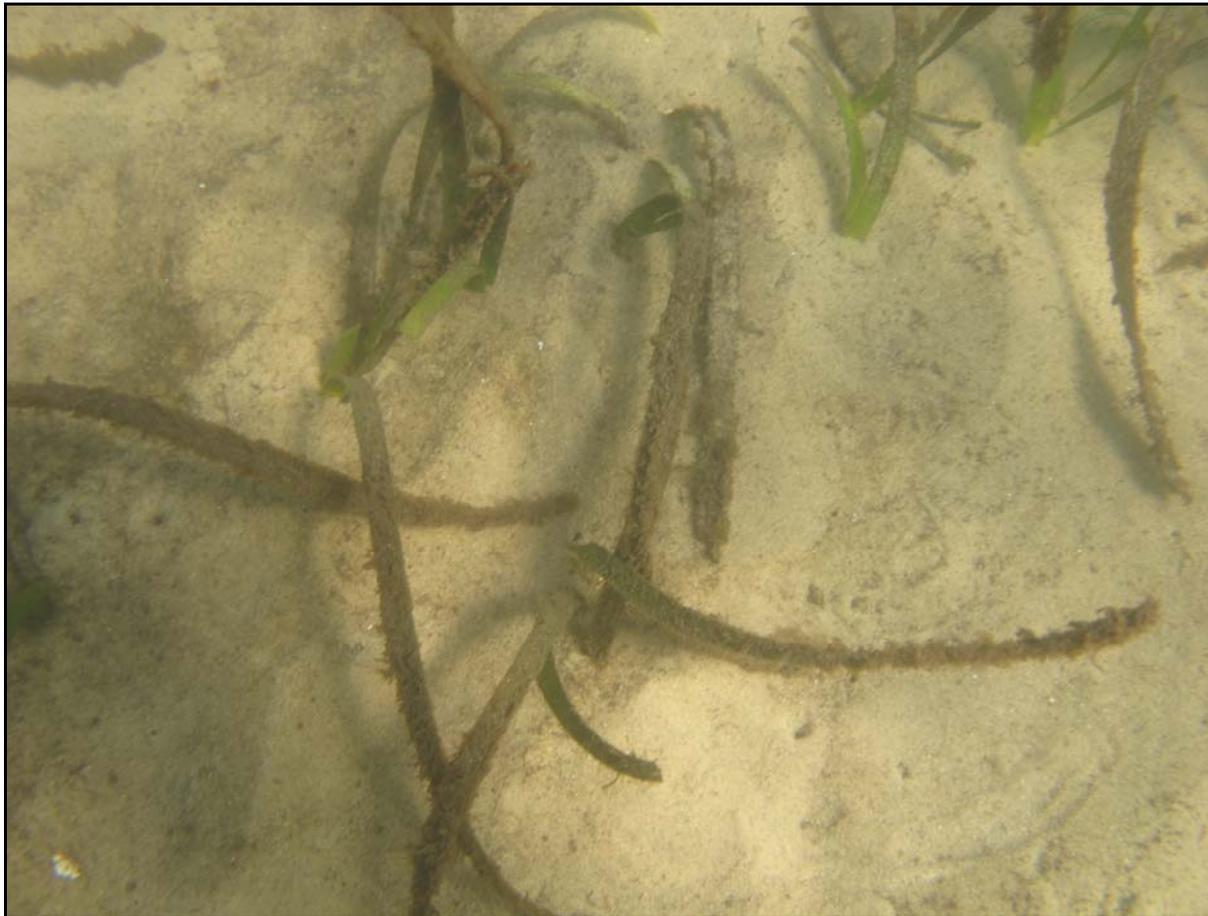
Plate 1: *P. australis* at Patch 3 in September 2016 showing a thick cover of epiphytes

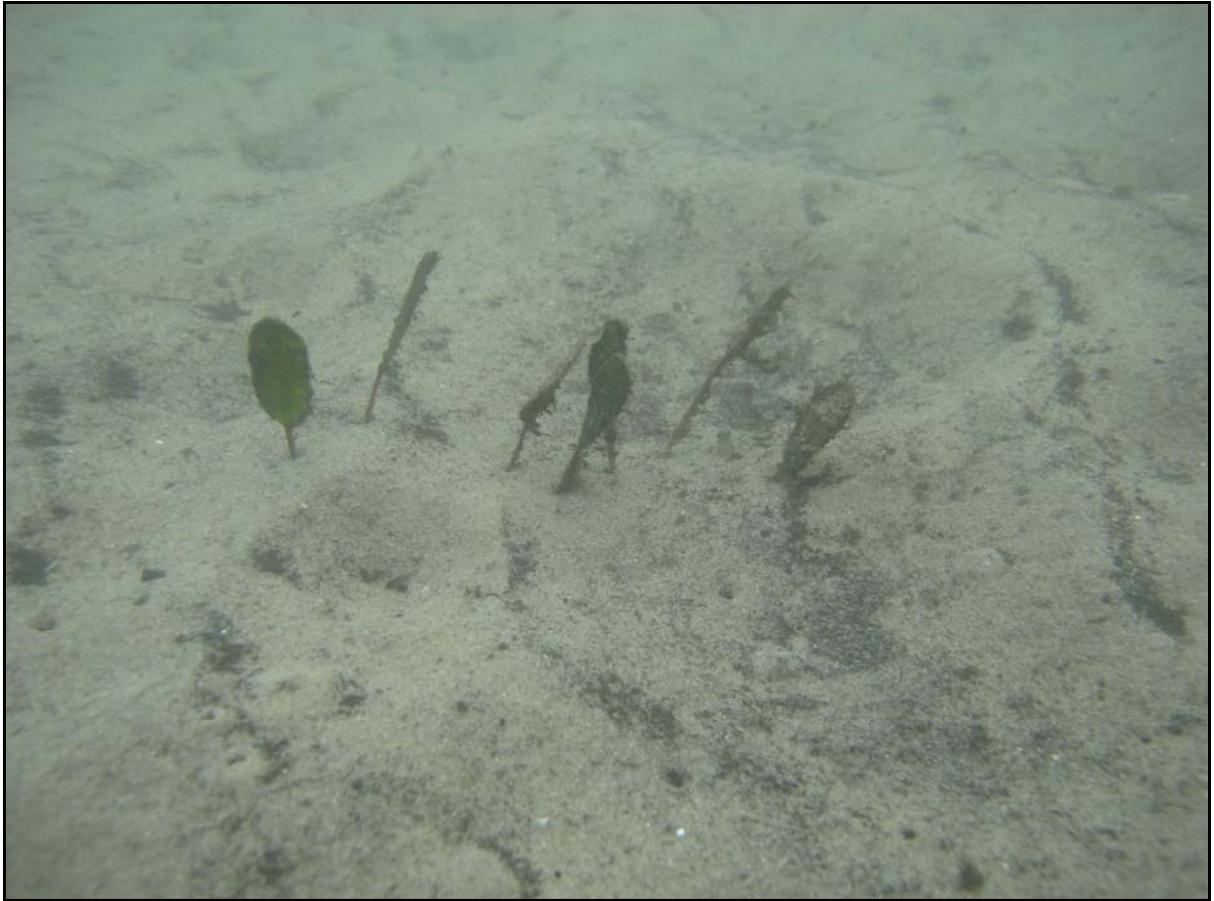
The mean density of *Halophila* spp. at Foreshore Beach in September 2016 was up to five times greater than what had been observed in June 2016 and compared to density of *Halophila* spp. in patches at Yarra Bay. (**Table 3-2**). Leaf length at all sites was similar but the cover of epiphytes on *Halophila* spp. in September 2016 (**Plate 2**) appeared to be higher than in June 2016 and compared to Yarra Bay.

Plate 2: Epiphytes on *Halophila* sp. at Foreshore Beach in September 2016
